**Flood Control Project Maintenance  
Levee Inspections**

**Fall 2019 Levee Maintenance Deficiency Summary Report**

<b>RD0349</b>	Overall LMA Rating	Total LMA Miles						
<b>Reclamation District No. 0349 Sutter Island</b>	<b>U</b>	<b>12.41</b>						
Rated Item	Maintenance Deficiency				Enforcement		Design & System Obsolescence	
	M Miles	U Miles	M + 4U Miles	Threshold %	M Miles	U Miles	M Miles	U Miles
<i>Earthen Levee</i>								
Vegetation	5.48	3.84	20.84	167.97%	0.14	0.57		
Trim / Thin Trees	0.26	0.04	0.42	3.39%				
Encroachments	0.24		0.24	1.93%	1.04	0.29		
Animal Control	0.18		0.18	1.45%				
Slope Stability	0.01		0.01	0.08%				
Crown Surface / Depressions / Rutting	0.01		0.01	0.08%				
Flood Preparedness & Training	0.12		0.12	0.97%				
<i>Supplemental</i>								
2017 USACE Erosion Survey	0.35		0.35	2.82%				
DRAFT DWR UCIP Field Study					0.50	0.01		
2017 Storm Damage	0.22		0.22	1.77%				
<i>LMA Totals:</i>	6.87	3.88	22.39	180.46%	1.68	0.87	0.00	0.00

**Flood Control Project Maintenance  
Levee Inspections****LMA District Cover Sheet  
Fall 2019 Levee Inspection Results****Reclamation District No. 0349 Sutter Island**

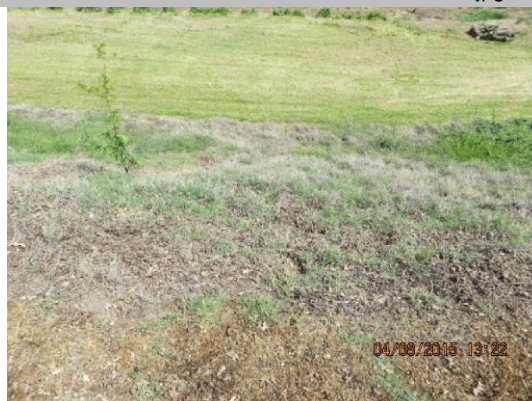
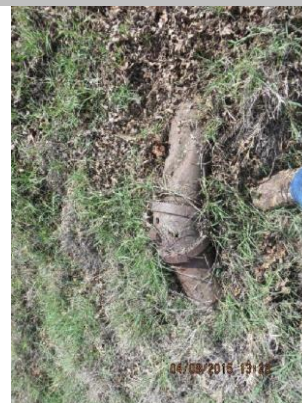
LM Start	1.17	Rating **	M	Issue No.	118	
LM End	1.17	Issue Type +	En	Location *		
Category	Supplemental			GPS Latitude/Longitude		
				Start	End	
Item	DRAFT DWR UCIP Field Study			38.271218 °	38.271218 °	
				-121.603468 °	-121.603468 °	
DWR ID	24166					
Comment Code						
Inspector Comment						
DS_ID:24166 FS_ID:44335 EP_NO: N/A Repair Type: Non-Urgent Crossing Status: Found UCIP Comments: Pipe abandoned and should be done so properly or verified as having been done so properly. FIELD_STRUCT_DESC: 6-inch irrigation pipe of unknown material through the levee, 4.5 feet below the levee crown. Pump and pump house no longer on the landside (LS) toe. [Additional Reference(s): DWR Levee Log, 2005. USACE Sacramento O&M Manual Unit No. 110, May 1959, revised 29 Dec 2016, (HLM 1.2)] FS Date: 4/9/2015

Pipe visible on LS slope.

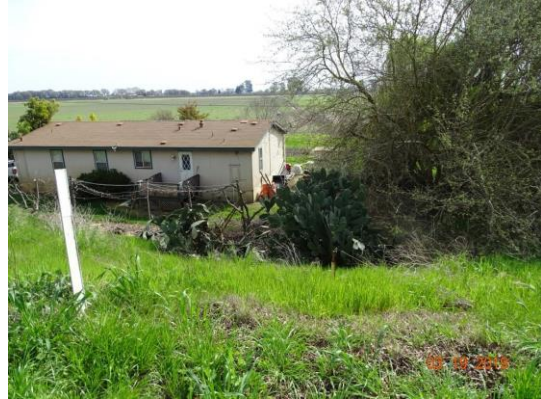
Photo 1 of 1 : FA\_2019\_RD0349\_206\_113\_20190826\_00026.jpg

LM Start	1.20	Rating **	M	Issue No.	113
LM End	1.23	Issue Type +	En	Location *	LS
Category	Earthen Levee			GPS Latitude/Longitude	
				Start	End
Item	Vegetation			38.271733 °	38.272148 °
				-121.603365 °	-121.603245 °
DWR ID	DWR_RD0349_03_f_2018_113				
Comment Code					
V6 : Landscaping					
Inspector Comment					
Remove cactus from the landside slope.

View of cactus on the landside slope (Spring 2019).

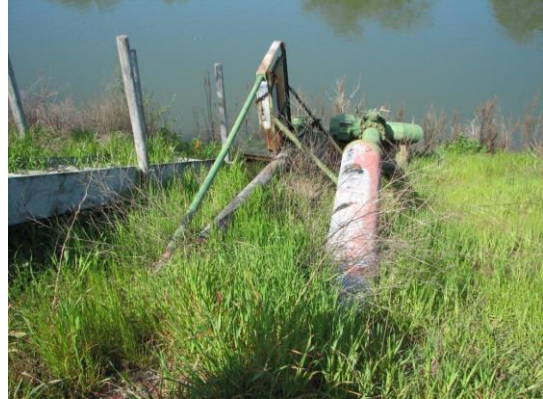
Photo 1 of 1 : UCIP\_FA\_2019\_47043\_36864.jpg

Comment Code					
Inspector Comment					
DS_ID:24169 FS_ID:47043 EP_NO: 11744 Repair Type: Non-Urgent Crossing Status: Found UCIP Comments: Dense vegetation limits the inspector's visibility to identify signs of pipe failure (leaks) through the levee slopes. Recommend removing vegetation along pipe alignment to conduct proper inspection of structure and appurtenances. Note date on photos should be 3/18/09 not 7/26/08 camera metadata is incorrect. FIELD_STRUCT_DESC: 1 of 2: 8-inch steel irrigation pipe through the levee, 3.7 feet below the crown. 8-inch pipe is reduced to 3-inch pipe on the waterside (WS). Steel cutoff wall around pipe at center of levee. Siphon breaker at landside (LS) shoulder. Siphon breaker at LS shoulder. Slant pump on WS. Discharge structure at LS toe. Rock revetment on WS slope. (8-inch pipe authorized under Permit No. 11744, 1976 - J. Wiedman, also approved at different location is a 14-inch pipe through levee and 12-inch in the slopes) [Additional Reference(s): DWR Levee Log, 2005] FS Date: 3/19/2009

View of pipe, control panel, and stairs. 2 pipes go through levee 14-inch and 8-inch.

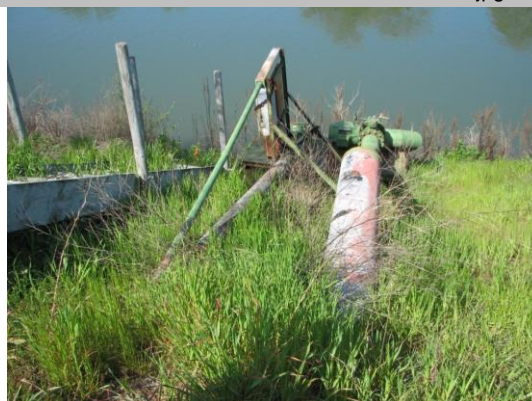
Photo 1 of 3 : UCIP\_FA\_2019\_47042\_36856.jpg

Comment Code						
Inspector Comment						
DS_ID:24168 FS_ID:47042 EP_NO: 11744 Repair Type: Non-Urgent Crossing Status: Found UCIP Comments: Dense vegetation limits the inspector's visibility to identify signs of pipe failure (leaks) through the levee slopes. Recommend removing vegetation along pipe alignment to conduct proper inspection of structure and appurtenances. Note date on photos should be 3/18/09 not 7/26/08 camera metadata is incorrect. FIELD_STRUCT_DESC: 2 of 2: 14-inch steel irrigation pipe and 2-inch electric conduit through the levee, 4.4 feet below the levee crown. Pipe section on both levee slopes reduced to 12-inch steel pipe . Steel cutoff wall around pipe at center of levee. Siphon breaker at landside (LS) shoulder. Slant pump on waterside (WS) with staircase access. Discharge structure at LS toe. Rock revetment on WS slope. (14-inch pipe through levee and 12-inch in the slopes authorized under Permit No. 11744, 1976 - J. Wiedman, also approved at different location is a 8-inch pipe) [Additional Reference(s): DWR Levee Log, 2005] FS Date: 3/19/2009

Pump system located on waterward side.

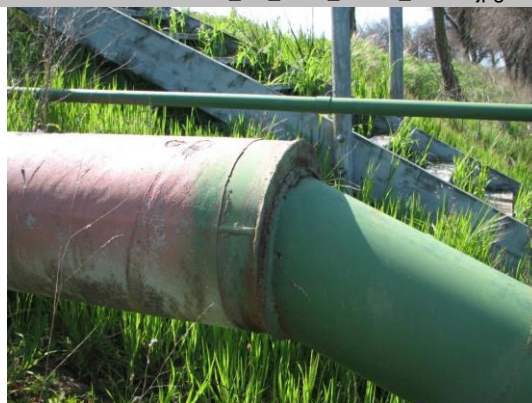
Photo 2 of 3 : UCIP\_FA\_2019\_47042\_36857.jpg

Pipe reduced from 14-inch to 10-inch and conduit through levee.

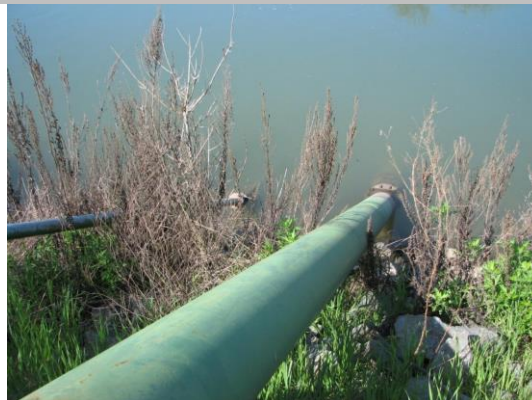
Photo 3 of 3 : UCIP\_FA\_2019\_47042\_36858.jpg

Comment Code						
Inspector Comment						
DS_ID:24168 FS_ID:47042 EP_NO: 11744 Repair Type: Non-Urgent Crossing Status: Found UCIP Comments: Dense vegetation limits the inspector's visibility to identify signs of pipe failure (leaks) through the levee slopes. Recommend removing vegetation along pipe alignment to conduct proper inspection of structure and appurtenances. Note date on photos should be 3/18/09 not 7/26/08 camera metadata is incorrect. FIELD_STRUCT_DESC: 2 of 2: 14-inch steel irrigation pipe and 2-inch electric conduit through the levee, 4.4 feet below the levee crown. Pipe section on both levee slopes reduced to 12-inch steel pipe . Steel cutoff wall around pipe at center of levee. Siphon breaker at landside (LS) shoulder. Slant pump on waterside (WS) with staircase access. Discharge structure at LS toe. Rock revetment on WS slope. (14-inch pipe through levee and 12-inch in the slopes authorized under Permit No. 11744, 1976 - J. Wiedman, also approved at different location is a 8-inch pipe) [Additional Reference(s): DWR Levee Log, 2005] FS Date: 3/19/2009

Rip rap along the waterward toe.

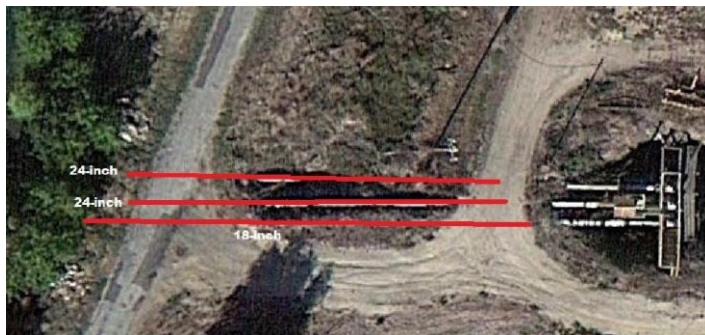
Photo 1 of 2 : UCIP\_FA\_2019\_43446\_36725.jpg

DS\_ID:24229  
FS\_ID:43446  
EP\_NO: 2954  
Repair Type: Non-Urgent  
Crossing Status: Found  
UCIP Comments: Dense vegetation limits the inspector's visibility to identify signs of pipe failure (leaks) through the levee slopes. Recommend removing vegetation along pipe alignment to conduct proper inspection of structure and appurtenances. Note date on photos should be 3/18/09 not 7/26/08 camera metadata is incorrect.  
FIELD\_STRUCT\_DESC: [R.D. No. 349 Drainage Pumping Plant] 1 of 3: 18-inch steel drainage pipe through the levee, 7.8 feet below the crown. Siphon breakers on waterside (WS) slope. Pumps on platform on landside (LS). [Additional Reference(s): DWR Levee Log, 2005. USACE Sacramento O&M Manual Unit No. 110, May 1959, revised 29 Dec 2016, (HLM 1.6)]  
FS Date: 3/19/2009

Aerial map showing alignment of 18-inch pipe.

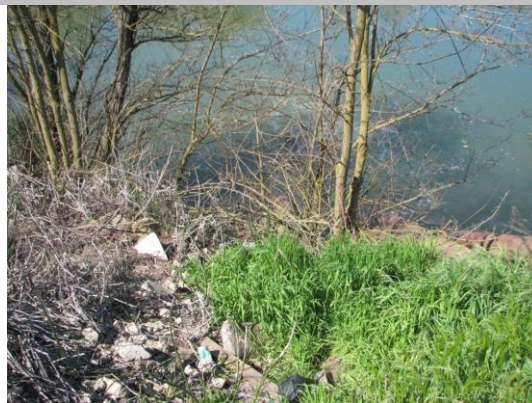
Photo 2 of 2 : UCIP\_FA\_2019\_43446\_36726.jpg

View of all 3 pipes through levee and visible on waterward toe.

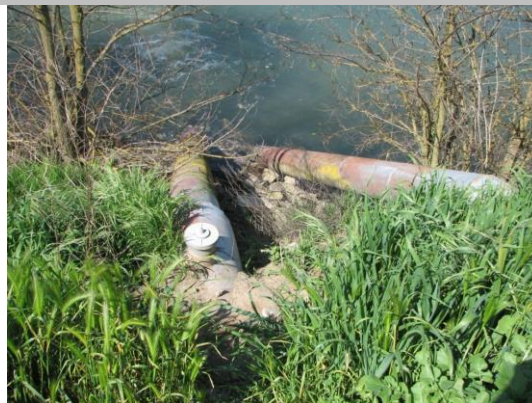
Photo 2 of 3 : UCIP\_FA\_2019\_43445\_36727.jpg

Comment Code					
Inspector Comment					
DS_ID:24228 FS_ID:43445 EP_NO: 2954 Repair Type: Non-Urgent Crossing Status: Found UCIP Comments: Dense vegetation limits the inspector's visibility to identify signs of pipe failure (leaks) along the slope. Recommend removing vegetation along pipe alignment to conduct proper inspection of structure and appurtenances. Note date on photos should be 3/18/09 not 7/26/08 camera metadata is incorrect. FIELD_STRUCT_DESC: [R.D. No. 349 Drainage Pumping Plant] 2 of 3: 24-inch steel drainage pipe through the levee, 7.8 feet below the crown. Siphon breakers on waterside (WS) slope. Pumps on platform on landside (LS). [Additional Reference(s): DWR Levee Log, 2005. USACE Sacramento O&M Manual Unit No. 110, May 1959, revised 29 Dec 2016, (HLM 1.6)] FS Date: 3/19/2009

View of pipe on waterward side--pipe running. Siphon breaker visible on pipe.

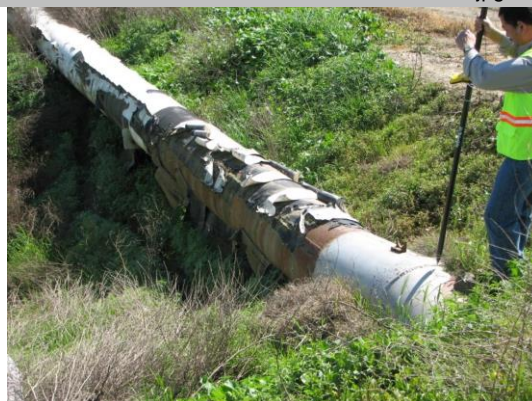
Photo 3 of 3 : UCIP\_FA\_2019\_43445\_36728.jpg

Comment Code						
Inspector Comment						
DS_ID:24228 FS_ID:43445 EP_NO: 2954 Repair Type: Non-Urgent Crossing Status: Found UCIP Comments: Dense vegetation limits the inspector's visibility to identify signs of pipe failure (leaks) along the slope. Recommend removing vegetation along pipe alignment to conduct proper inspection of structure and appurtenances. Note date on photos should be 3/18/09 not 7/26/08 camera metadata is incorrect. FIELD_STRUCT_DESC: [R.D. No. 349 Drainage Pumping Plant] 2 of 3: 24-inch steel drainage pipe through the levee, 7.8 feet below the crown. Siphon breakers on waterside (WS) slope. Pumps on platform on landside (LS). [Additional Reference(s): DWR Levee Log, 2005. USACE Sacramento O&M Manual Unit No. 110, May 1959, revised 29 Dec 2016, (HLM 1.6)] FS Date: 3/19/2009

Pipe is wrapped--unwrapped coating.

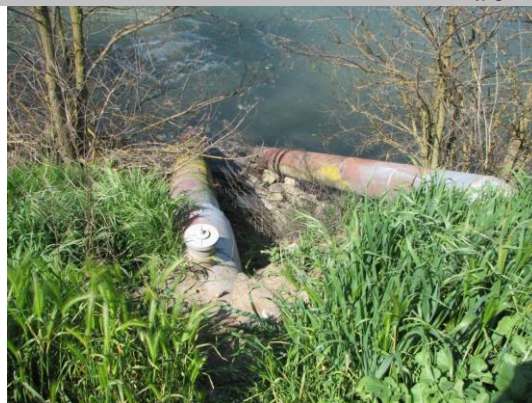
Photo 2 of 3 : UCIP\_FA\_2019\_21632\_36731.jpg

DS\_ID:24171  
FS\_ID:21632  
EP\_NO: 2954  
Repair Type: Non-Urgent  
Crossing Status: Found  
UCIP Comments: Dense vegetation limits the inspector's visibility to identify signs of pipe failure (leaks) along the slope. Recommend removing vegetation along pipe alignment to conduct proper inspection of structure and appurtenances. Note date on photos should be 3/18/09 not 7/26/08 camera metadata is incorrect.  
FIELD\_STRUCT\_DESC: [R.D. No. 349 Drainage Pumping Plant] 3 of 3: 24-inch steel drainage pipe through the levee, 7.8 feet below the crown. Metal cutoff wall around pipe at landside (LS) shoulder. Siphon breakers on waterside (WS) slope. Two anchor posts driven into levee on each side of pipe. Pumps on platform on LS. (additional pump and 24-inch pipe to existing district pumping plant authorized under Permit No. 2954, 1959 - Reclamation District No. 349 [RD0349]) [Additional Reference(s): DWR Levee Log, 2005]

View of waterward side--2-24 inch pipes.

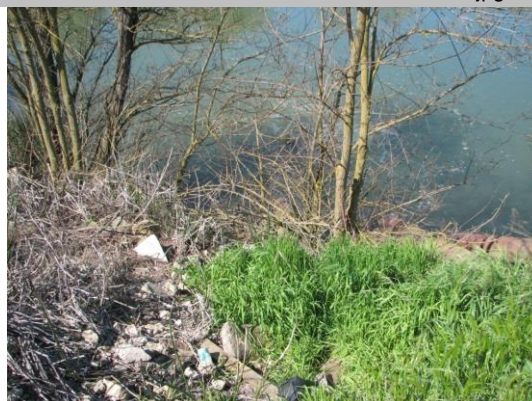
Photo 3 of 3 : UCIP\_FA\_2019\_21632\_36734.jpg

Comment Code						
Inspector Comment						
DS_ID:24171 FS_ID:21632 EP_NO: 2954 Repair Type: Non-Urgent Crossing Status: Found UCIP Comments: Dense vegetation limits the inspector's visibility to identify signs of pipe failure (leaks) along the slope. Recommend removing vegetation along pipe alignment to conduct proper inspection of structure and appurtenances. Note date on photos should be 3/18/09 not 7/26/08 camera metadata is incorrect. FIELD_STRUCT_DESC: [R.D. No. 349 Drainage Pumping Plant] 3 of 3: 24-inch steel drainage pipe through the levee, 7.8 feet below the crown. Metal cutoff wall around pipe at landside (LS) shoulder. Siphon breakers on waterside (WS) slope. Two anchor posts driven into levee on each side of pipe. Pumps on platform on LS. (additional pump and 24-inch pipe to existing district pumping plant authorized under Permit No. 2954, 1959 - Reclamation District No. 349 [RD0349]) [Additional Reference(s): DWR Levee Log, 2005] FS Date: 3/19/2009

All 3 pipes visible on waterward side--tall grass limits inspection on waterward side.

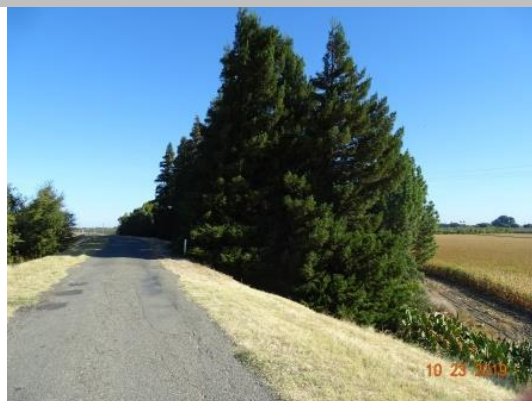
Photo 1 of 1 : FA\_2019\_RD0349\_206\_39\_20191025\_00093.jpg

LM Start	1.69	Rating **	U	Issue No.	39
LM End	1.76	Issue Type +	En	Location *	LS
Category	Earthen Levee			GPS Latitude/Longitude	
				Start	End
Item	Vegetation			38.278289 °	38.279339 °
				-121.600372 °	-121.600306 °
DWR ID	DWR_RD0349_03_f_2017_39				
Comment Code					
V6 : Landscaping					
Inspector Comment					
Remove cactus and trim and thin evergreens to allow insect and access.

View looking upstream at cactus and evergreen landscaping trees on the landside slope (Fall 2019).

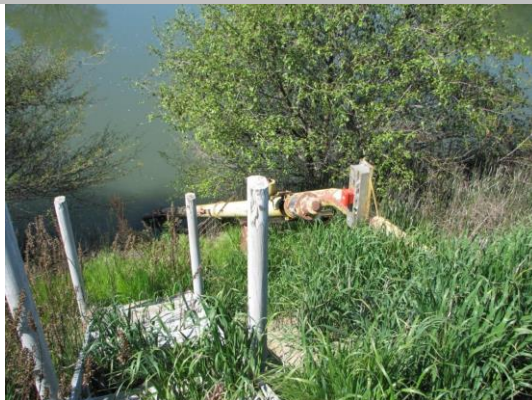
Photo 1 of 3 : UCIP\_FA\_2019\_47045\_36736.jpg

Comment Code					
Inspector Comment					
DS_ID:24172 FS_ID:47045 EP_NO: N/A Repair Type: Non-Urgent Crossing Status: Found UCIP Comments: Dense vegetation limits the inspector's visibility to identify signs of pipe failure (leaks) through the levee slopes. Recommend removing vegetation along pipe alignment to conduct proper inspection of structure and appurtenances. Note date on photos should be 3/18/09 not 7/26/08 camera metadata is incorrect. FIELD_STRUCT_DESC: 1 of 2: 12-inch irrigation pipe of unknown material and 2-inch electrical conduit through the levee, 8.0 feet below the levee crown. Siphon breaker in pipe riser on landside (LS) slope. Concrete standpipe at LS toe. Pump on waterside (WS) with stairway access. [Additional Reference(s): DWR Levee Log, 2005] FS Date: 3/19/2009

View of waterward side--pump, pipe, control panel, and stairway.

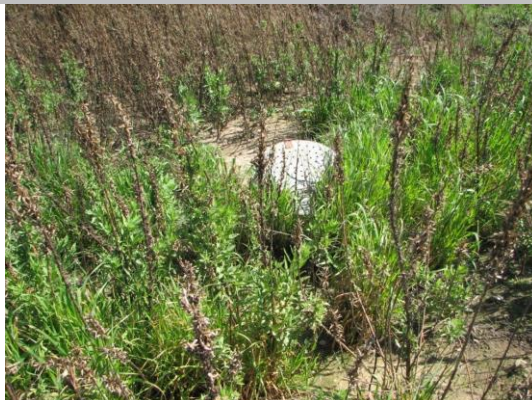
Photo 2 of 3 : UCIP\_FA\_2019\_47045\_36735.jpg

Stand pipe located on landward shoulder--pipe locked.

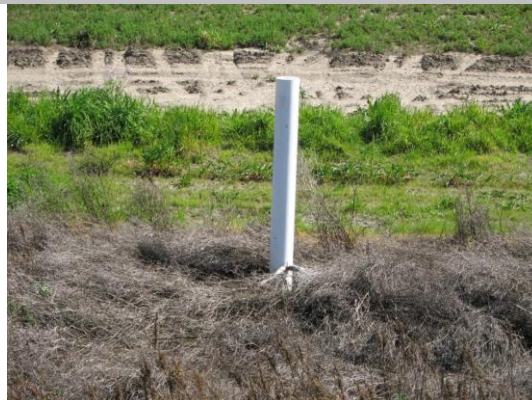
Photo 3 of 3 : UCIP\_FA\_2019\_47045\_36737.jpg

Comment Code						
Inspector Comment						
DS_ID:24172 FS_ID:47045 EP_NO: N/A Repair Type: Non-Urgent Crossing Status: Found UCIP Comments: Dense vegetation limits the inspector's visibility to identify signs of pipe failure (leaks) through the levee slopes. Recommend removing vegetation along pipe alignment to conduct proper inspection of structure and appurtenances. Note date on photos should be 3/18/09 not 7/26/08 camera metadata is incorrect. FIELD_STRUCT_DESC: 1 of 2: 12-inch irrigation pipe of unknown material and 2-inch electrical conduit through the levee, 8.0 feet below the levee crown. Siphon breaker in pipe riser on landside (LS) slope. Concrete standpipe at LS toe. Pump on waterside (WS) with stairway access. [Additional Reference(s): DWR Levee Log, 2005] FS Date: 3/19/2009

Tall thin stand pipe located on landward side--unable to find pipe.

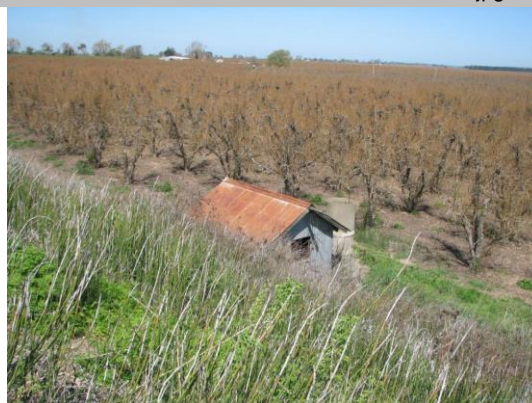
Photo 1 of 2 : UCIP\_FA\_2019\_21634\_36739.jpg

Comment Code					
Inspector Comment					
DS_ID:24173					
FS_ID:21634					
EP_NO: N/A					
Repair Type: Non-Urgent					
Crossing Status: Found					
UCIP Comments: Dense vegetation limits the inspector's visibility to identify signs of pipe failure (leaks) through the levee slopes.					
Recommend removing vegetation along pipe alignment to conduct proper inspection of structure and appurtenances. Note date on photos should be 3/18/09 not 7/26/08 camera metadata is incorrect.					
FIELD_STRUCT_DESC: 8-inch steel irrigation pipe through the levee, 6.7 feet below the levee crown. Pump in pump house and concrete standpipe located on the landside (LS) toe. [Additional Reference(s): DWR Levee Log, 2005. USACE Sacramento O&M Manual Unit No. 110, May 1959, revised 29 Dec 2016, (HLM 2.1)]					
FS Date: 3/19/2009

View of landward side--pump house and stand pipe.

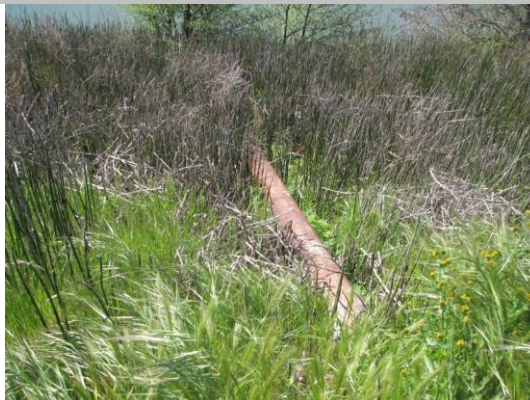
Photo 2 of 2 : UCIP\_FA\_2019\_21634\_36738.jpg

Comment Code						
Inspector Comment						
DS_ID:24173						
FS_ID:21634						
EP_NO: N/A						
Repair Type: Non-Urgent						
Crossing Status: Found						
UCIP Comments: Dense vegetation limits the inspector's visibility to identify signs of pipe failure (leaks) through the levee slopes.						
Recommend removing vegetation along pipe alignment to conduct proper inspection of structure and appurtenances. Note date on photos should be 3/18/09 not 7/26/08 camera metadata is incorrect.						
FIELD_STRUCT_DESC: 8-inch steel irrigation pipe through the levee, 6.7 feet below the levee crown. Pump in pump house and concrete standpipe located on the landside (LS) toe. [Additional Reference(s): DWR Levee Log, 2005. USACE Sacramento O&M Manual Unit No. 110, May 1959, revised 29 Dec 2016, (HLM 2.1)]						
FS Date: 3/19/2009

View of waterward side--dense vegetation limits inspection.

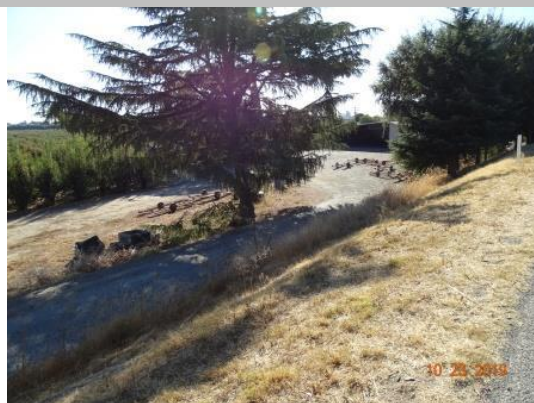
Photo 1 of 1 : FA\_2019\_RD0349\_206\_40\_20191025\_00094.jpg

LM Start	2.47	Rating **	M	Issue No.	40
LM End	2.54	Issue Type +	En	Location *	LS
Category	Earthen Levee			GPS Latitude/Longitude	
				Start	End
Item	Encroachments			38.288256 °	38.289297 °
				-121.603384 °	-121.603306 °
DWR ID	DWR_RD0349_03_f_2017_40				
Comment Code					
EQ : Equipment					
Inspector Comment					
Move ag equipment away from landside toe to allow a minimum 10 foot access.

View looking downstream at ag equipment within 10 feet of the toe (Fall 2019).

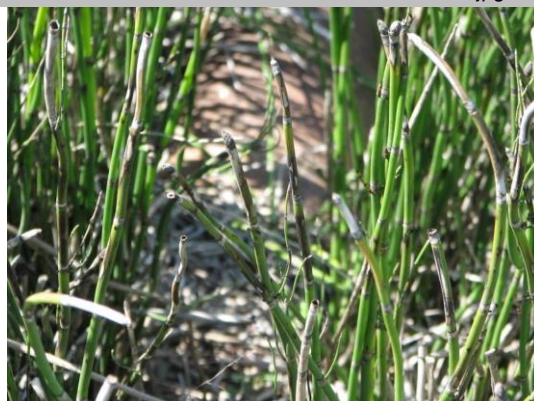
Photo 2 of 3 : UCIP\_FA\_2019\_43423\_36865.jpg

Comment Code						
Inspector Comment						
DS_ID:24176 FS_ID:43423 EP_NO: N/A Repair Type: Non-Urgent Crossing Status: Found UCIP Comments: Need to contact owner--If crossing is no longer used by owner, the owner will need to coordinate with DWR Inspector and CVFPB to remove crossing according to Title 23 requirements. Dense vegetation limits the inspector's visibility to identify signs of pipe failure (leaks) through the levee slopes. Recommend removing vegetation along pipe alignment to conduct proper inspection of structure and appurtenances. Note date on photos should be 3/18/09 not 7/26/08 camera metadata is incorrect. FIELD_STRUCT_DESC: *ABANDONED* 10-inch steel irrigation pipe through the levee, 8.2 feet below the levee crown. Pipe has plate welded on the waterside (WS) end. 3-inch galvanized pipe runs parallel to 10-inch pipe. Abandoned tank on WS slope. Distribution box and concrete standpipe at landside (LS) toe. [Additional Reference(s): DWR Levee Log, 2005. USACE Sacramento O&M Manual Unit No. 110, May 1959, revised 29 Dec 2016, (HLM 2.7)] FS Date: 3/19/2009

Pipe visible on waterward side.

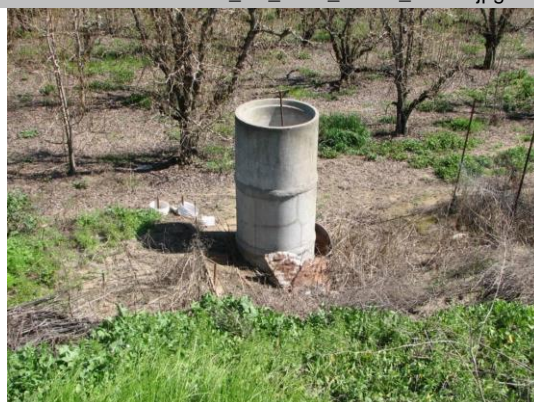
Photo 3 of 3 : UCIP\_FA\_2019\_43423\_36867.jpg

Stand pipe located on landward toe.

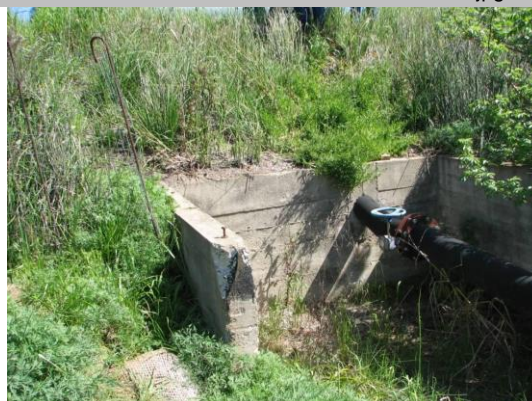
Photo 2 of 3 : UCIP\_FA\_2019\_43424\_36871.jpg

Comment Code						
Inspector Comment						
DS_ID:24177 FS_ID:43424 EP_NO: N/A Repair Type: Non-Urgent Crossing Status: Found UCIP Comments: 2007 Erosion Repair Site location?--Need to contact owner to determine if crossing is still in use. If crossing is no longer used by owner, the owner will need to coordinate with DWR Inspector and CVFPB to remove crossing according to Title 23 requirements. Dense vegetation limits the inspector's visibility to identify signs of pipe failure (leaks) through the levee slopes. Recommend removing vegetation along pipe alignment to conduct proper inspection of structure and appurtenances. Note date on photos should be 3/18/09 not 7/26/08 camera metadata is incorrect. FIELD_STRUCT_DESC: *ABANDONED* 8-inch steel irrigation pipe through the levee, 8.7 feet below the crown. Headwall and gate valve on the landside (LS). (re-installation of 8-inch pipe on waterside (WS) authorized under Permit No. 18345, 2012 - Wheeler and Thomas LLC) [Additional Reference(s): DWR Levee Log, 2005] FS Date: 3/19/2009

View of waterward side--headwall, pipe, and gate valve.

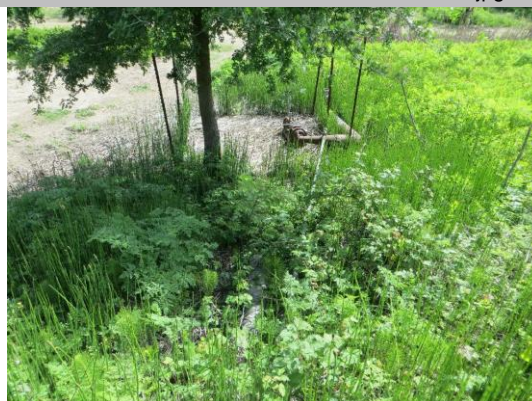
Photo 1 of 3 : UCIP\_FA\_2019\_53345\_73743.jpg

DS\_ID:24178  
FS\_ID:53345  
EP\_NO: 18345  
Repair Type: Non-Urgent  
Crossing Status: Found  
UCIP Comments: 7/24/2018 Same as last inspection. Unable to perform visual inspection due to dense vegetation on both WS and LS. Contact owner to see if in operation; otherwise needs to be abandoned properly. Crossing downgraded to Non-Urgent due to no signs of integrity issues found during inspection (DWR UCIP - D. Sanoski). 8/17/2016 Unable to determine condition of crossing due to dense vegetation on both WS and LS. Need to contact owner to determine status of crossing. Unable to confirm if WS pipe capped with metal plate. (DWR UCIP - omagana) 4/08/2015 Appears abandoned and if so should be done so properly. Pipe open at LS toe. Unable to verify if plate is welded over WS end. (DWR UCIP - omagana) FIELD\_STRUCT\_DESC: \*ABANDONED\* 8-inch steel irrigation pipe through the levee, 4.5 feet below the crown. Corrugated metal cutoff wall around pipe at center of levee. Siphon breaker is located on the waterside (WS) shoulder. Pump is located on the landside (LS). Gate valve is located on the WS. 1.5-inch filler pipe at same location. Plate welded to WS end. (8-inch installed under Permit No. 6321, 1969 - B.C. Wheeler; re-installation of 8-inch pipe on waterside (WS) authorized under Permit No. 18345, 2012 - Wheeler and Thomas LLC). [Additional Reference(s): DWR Levee Log, 2005]

Pipe and pump platform on LS toe.

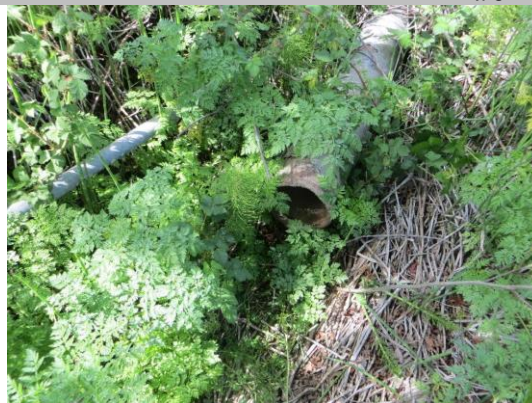
Photo 2 of 3 : UCIP\_FA\_2019\_53345\_73742.jpg

1.5-inch filler pipe and 8-inch steel irrigation pipe at LS toe.

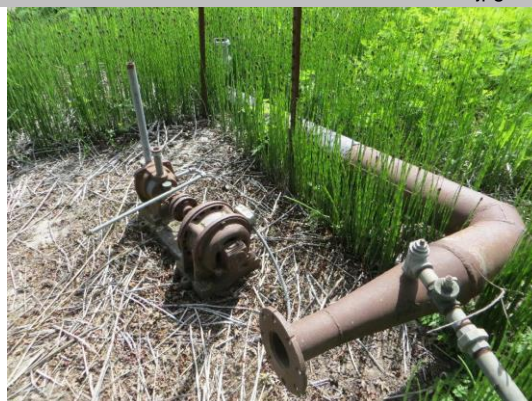
Photo 3 of 3 : UCIP\_FA\_2019\_53345\_73741.jpg

Comment Code						
Inspector Comment						
DS_ID:24178 FS_ID:53345 EP_NO: 18345 Repair Type: Non-Urgent Crossing Status: Found UCIP Comments: 7/24/2018 Same as last inspection. Unable to perform visual inspection due to dense vegetation on both WS and LS. Contact owner to see if in operation; otherwise needs to be abandoned properly. Crossing downgraded to Non-Urgent due to no signs of integrity issues found during inspection (DWR UCIP - D. Sanoski).8/17/2016 Unable to determine condition of crossing due to dense vegetation on both WS and LS. Need to contact owner to determine status of crossing. Unable to confirm if WS pipe capped with metal plate. (DWR UCIP - omagana)4/08/2015 Appears abandoned and if so should be done so properly. Pipe open at LS toe. Unable to verify if plate is welded over WS end. (DWR UCIP - omagana) FIELD_STRUCT_DESC: *ABANDONED* 8-inch steel irrigation pipe through the levee, 4.5 feet below the crown. Corrugated metal cutoff wall around pipe at center of levee. Siphon breaker is located on the waterside (WS) shoulder. Pump is located on the landside (LS). Gate valve is located on the WS. 1.5-inch filler pipe at same location. Plate welded to WS end. (8-inch installed under Permit No. 6321, 1969 - B.C. Wheeler; re-installation of 8-inch pipe on waterside (WS) authorized under Permit No. 18345, 2012 - Wheeler and Thomas LLC). [Additional Reference(s): DWR Levee Log, 2005] FS Date: 7/24/2018 4:15:00 PM

Abandoned pump at LS toe.

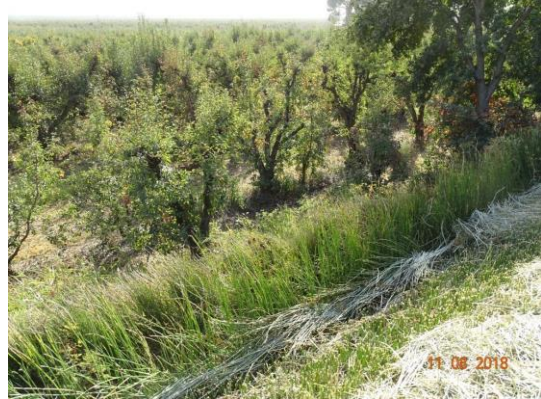
Photo 1 of 1 : FA\_2019\_RD0349\_206\_105\_20190826\_00025.jpg

LM Start	3.04	Rating **	M	Issue No.	105
LM End	3.15	Issue Type +	En	Location *	LS
Category	Earthen Levee			GPS Latitude/Longitude	
				Start	End
Item	Encroachments			38.296388°	38.297773°
				-121.604558°	-121.603635°
DWR ID	DWR_RD0349_03_f_2018_105				
Comment Code					
CR : Crops					
Inspector Comment					
Orchard trees are located at landside toe.

View looking slightly downstream at orchard trees on the landside toe (November 2018).

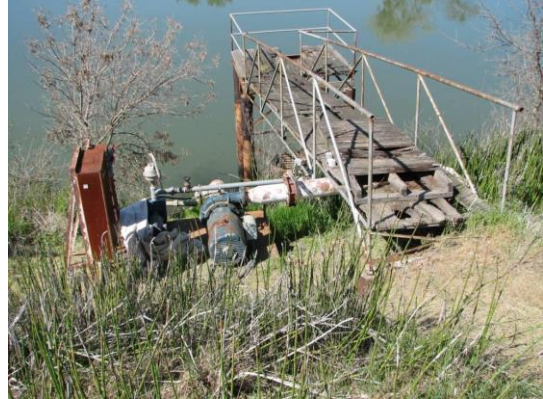
Photo 1 of 3 : UCIP\_FA\_2019\_44389\_36873.jpg

LM Start	3.34	Rating **	M	Issue No.	129
LM End	3.34	Issue Type +	En	Location *	
Category	Supplemental			GPS Latitude/Longitude	
				Start	End
Item	DRAFT DWR UCIP Field Study			38.299703°	38.299703°
				-121.601112°	-121.601112°
DWR ID	24179				
Comment Code					
Inspector Comment					
DS_ID:24179 FS_ID:44389 EP_NO: N/A Repair Type: Non-Urgent Crossing Status: Found UCIP Comments: Crossing altered--need to contact owner to obtain permit number authorizing work. Dense vegetation limits the inspector's visibility to identify signs of pipe failure (leaks) along the slope. Recommend removing vegetation along pipe alignment to conduct proper inspection of structure and appurtenances. Note date on photos should be 3/18/09 not 7/26/08 camera metadata is incorrect. FIELD_STRUCT_DESC: *DELETE* FS Date: 4/9/2015

View of waterward side--pump, control panel, pipe, and walkway.

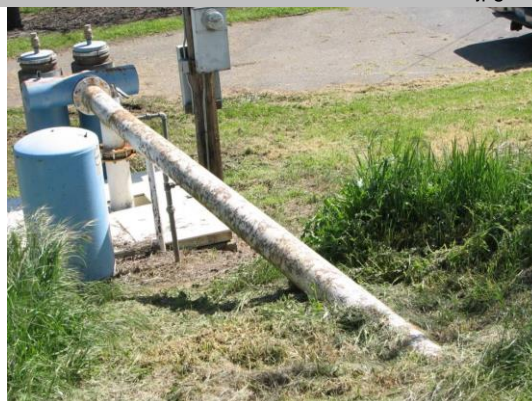
Photo 3 of 3 : UCIP\_FA\_2019\_44389\_36874.jpg

LM Start	3.34	Rating **	M	Issue No.	129 (cont)	
LM End	3.34	Issue Type +	En	Location *		
Category	Supplemental			GPS Latitude/Longitude		
				Start	End	
Item	DRAFT DWR UCIP Field Study			38.299703 °	38.299703 °	
				-121.601112 °	-121.601112 °	
DWR ID	24179					
Comment Code						
Inspector Comment						
DS_ID:24179 FS_ID:44389 EP_NO: N/A Repair Type: Non-Urgent Crossing Status: Found UCIP Comments: Crossing altered--need to contact owner to obtain permit number authorizing work. Dense vegetation limits the inspector's visibility to identify signs of pipe failure (leaks) along the slope. Recommend removing vegetation along pipe alignment to conduct proper inspection of structure and appurtenances. Note date on photos should be 3/18/09 not 7/26/08 camera metadata is incorrect. FIELD_STRUCT_DESC: *DELETE* FS Date: 4/9/2015

View of landward side.

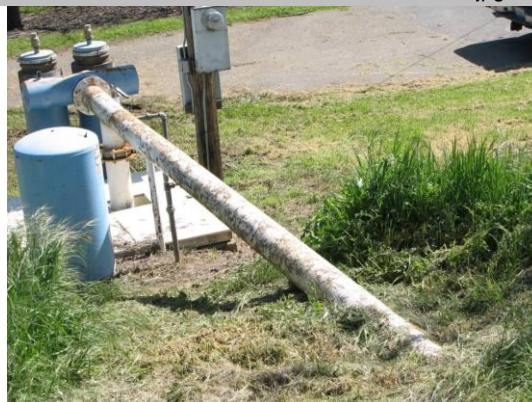
Photo 1 of 2 : UCIP\_FA\_2019\_44390\_73745.jpg

LM Start	3.34	Rating **	M	Issue No.	130
LM End	3.34	Issue Type +	En	Location *	
Category	Supplemental			GPS Latitude/Longitude	
				Start	End
Item	DRAFT DWR UCIP Field Study			38.299718 °	38.299718 °
				-121.601095 °	-121.601095 °
DWR ID	24214				
Comment Code					
Inspector Comment					
DS_ID:24214 FS_ID:44390 EP_NO: N/A Repair Type: Non-Urgent Crossing Status: Found UCIP Comments: Walway and pier abandoned and appears to be a hazard that should be removed. FIELD_STRUCT_DESC: 10-inch steel irrigation pipe through the levee, 5.8-feet below the levee crown. Pump, butterfly valve, and electrical panel on waterside (WS) slope. Pier and walkway next to pump on WS slope. Power pole, filters, and distribution box at landside (LS) toe. [Additional Reference(s): DWR Levee Log, 2005. USACE Sacramento O&M Manual Unit No. 110, May 1959, revised 29 Dec 2016, (HLM 3.5)] FS Date: 4/9/2015

Pipe, filter system, powerpole, and distribution box at LS toe.

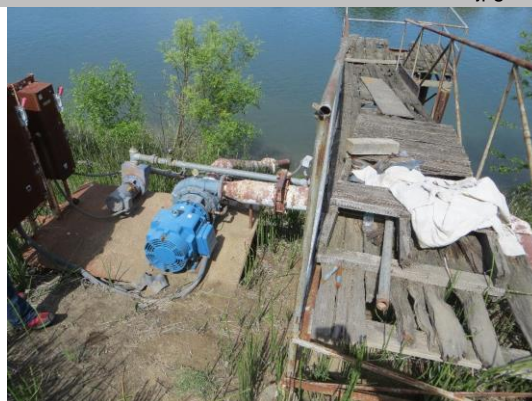
Photo 2 of 2 : UCIP\_FA\_2019\_44390\_73746.jpg

Comment Code						
Inspector Comment						
DS_ID:24214						
FS_ID:44390						
EP_NO: N/A						
Repair Type: Non-Urgent						
Crossing Status: Found						
UCIP Comments: Walway and pier abandoned and appears to be a hazard that should be removed.						
FIELD_STRUCT_DESC: 10-inch steel irrigation pipe through the levee, 5.8-feet below the levee crown. Pump, butterfly valve, and electrical panel on waterside (WS) slope. Pier and walkway next to pump on WS slope. Power pole, filters, and distribution box at landside (LS) toe.						
[Additional Reference(s): DWR Levee Log, 2005. USACE Sacramento O&M Manual Unit No. 110, May 1959, revised 29 Dec 2016, (HLM 3.5)]						
FS Date: 4/9/2015

Pump, electrical panel, butterfly valve, and walkway on WS slope.

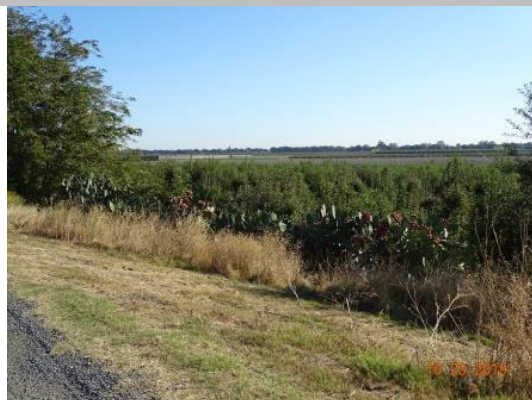
Photo 1 of 1 : FA\_2019\_RD0349\_206\_45\_20191025\_00097.jpg

LM Start	3.39	Rating **	M	Issue No.	45
LM End	3.39	Issue Type +	En	Location *	LS
Category	Earthen Levee			GPS Latitude/Longitude	
				Start	End
Item	Vegetation			38.300204 °	38.300204 °
				-121.600469 °	-121.600469 °
DWR ID	DWR_RD0349_03_f_2017_45				
Comment Code					
V6 : Landscaping					
Inspector Comment					
Remove large cactus on landside slope.

View looking downslope at large cactus on the landside slope (Fall 2019).

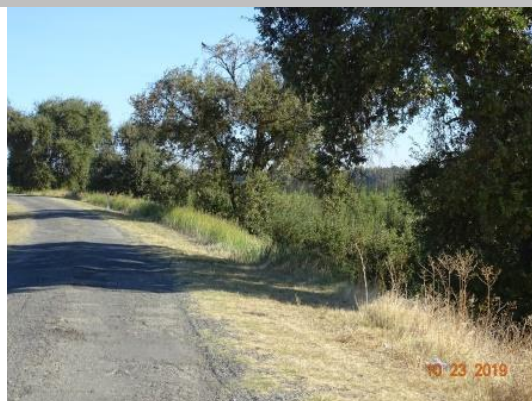
Photo 1 of 1 : FA\_2019\_RD0349\_206\_104\_20191025\_00098.jpg

LM Start	3.40	Rating **	U	Issue No.	104
LM End	3.93	Issue Type +	Ma	Location *	LS
Category	Earthen Levee			GPS Latitude/Longitude	
				Start	End
Item	Vegetation			38.300347 °	38.307097 °
				-121.600277 °	-121.596913 °
DWR ID	DWR_RD0349_03_f_2019_104				
Comment Code					
V1 : Control annual grass and weeds on the levee slopes and easements.					
Inspector Comment

View looking upstream at vegetation on the landside slope (Fall 2019).

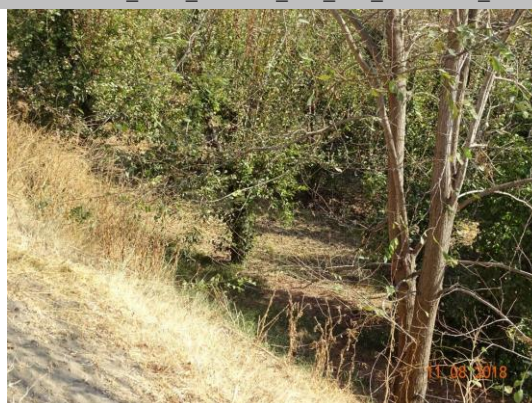
Photo 1 of 1 : FA\_2019\_RD0349\_206\_103\_20190826\_00024.jpg

LM Start	3.40	Rating **	M	Issue No.	103
LM End	3.57	Issue Type +	En	Location *	LS
Category	Earthen Levee			GPS Latitude/Longitude	
				Start	End
Item	Encroachments			38.300347 °	38.302612 °
				-121.600275 °	-121.599198 °
DWR ID	DWR_RD0349_03_f_2018_103				
Comment Code					
CR : Crops					
Inspector Comment					
Orchard trees are located on the landside toe.

View looking slightly upstream at orchard trees on the landside toe (November 2018).

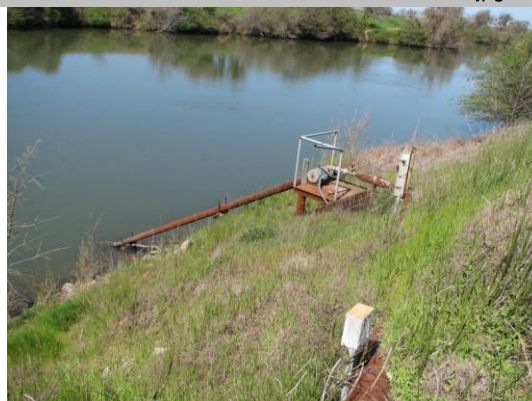
Photo 1 of 3 : UCIP\_FA\_2019\_21644\_36780.jpg

Comment Code					
Inspector Comment					
DS_ID:24180 FS_ID:21644 EP_NO: 9290 Repair Type: Non-Urgent Crossing Status: Found UCIP Comments: 03/16/2018 Levee logs indicates a 10-inch pipe present at this location however, permit records show pipe authorized and installed is 6-inch pipe. Need to field measure the WS pipe and update structure description. (DWR UCIP - O. Magana) 03/19/2009 Dense vegetation limits the inspector's visibility to identify signs of pipe failure (leaks) through the levee slopes. Recommend removing vegetation along pipe alignment to conduct proper inspection of structure and appurtenances. (DWR UCIP - O. Magana) FIELD_STRUCT_DESC: 10-inch steel irrigation pipe and 1.5-inch steel electrical conduit through the levee, 4.0 feet below the crown. Steel cutoff wall around pipe and conduit at center of levee. Pump and gate valve located on the waterside (WS) slope. 6-inch intake pipe extends from pump into channel. Distribution system at landside (LS) toe. (6-inch pipe and pump authorized under Permit No. 9290, 1975 - C. Van Loben Sels, 6-inch installed) [Additional Reference(s): DWR Levee Log, 2005] FS Date: 3/19/2009

View of waterward side.

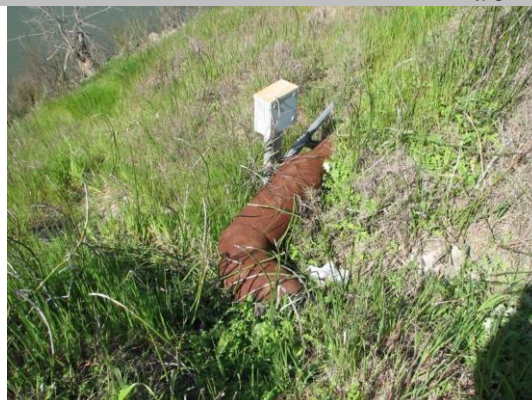
Photo 2 of 3 : UCIP\_FA\_2019\_21644\_36778.jpg

90 elbow at daylight and continues along slope and connects to pump.

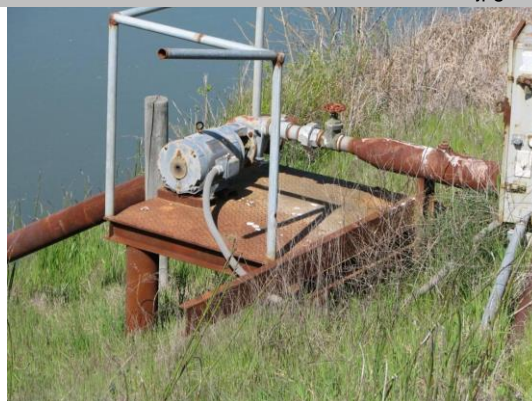
Photo 3 of 3 : UCIP\_FA\_2019\_21644\_36781.jpg

Comment Code						
Inspector Comment						
DS_ID:24180 FS_ID:21644 EP_NO: 9290 Repair Type: Non-Urgent Crossing Status: Found UCIP Comments: 03/16/2018 Levee logs indicates a 10-inch pipe present at this location however, permit records show pipe authorized and installed is 6-inch pipe. Need to field measure the WS pipe and update structure description. (DWR UCIP - O. Magana) 03/19/2009 Dense vegetation limits the inspector's visibility to identify signs of pipe failure (leaks) through the levee slopes. Recommend removing vegetation along pipe alignment to conduct proper inspection of structure and appurtenances. (DWR UCIP - O. Magana) FIELD_STRUCT_DESC: 10-inch steel irrigation pipe and 1.5-inch steel electrical conduit through the levee, 4.0 feet below the crown. Steel cutoff wall around pipe and conduit at center of levee. Pump and gate valve located on the waterside (WS) slope. 6-inch intake pipe extends from pump into channel. Distribution system at landside (LS) toe. (6-inch pipe and pump authorized under Permit No. 9290, 1975 - C. Van Loben Sels, 6-inch installed) [Additional Reference(s): DWR Levee Log, 2005] FS Date: 3/19/2009

Appurtenances located on waterward slope.

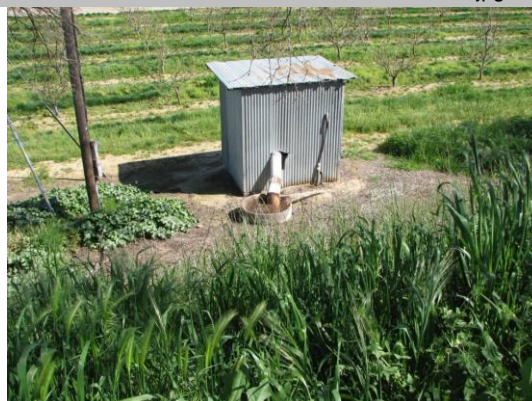
Photo 1 of 2 : UCIP\_FA\_2019\_43455\_36783.jpg

Comment Code						
Inspector Comment						
DS_ID:24201 FS_ID:43455 EP_NO: 15503 Repair Type: Non-Urgent Crossing Status: Found UCIP Comments: Dense vegetation limits the inspector's visibility to identify signs of pipe failure (leaks) through the levee slopes. Recommend removing vegetation along pipe alignment to conduct proper inspection of structure and appurtenances. Note date on photos should be 3/18/09 not 7/26/08 camera metadata is incorrect. FIELD_STRUCT_DESC: 10-inch steel irrigation pipe through the levee, 3.0 feet below the crown. Steel cutoff wall around pipe 24-inches landward of levee center. Pump and gate valve in pump house at the landside (LS) toe. Pipe is exposed along waterside (WS) slope. (10-inch pipe under Permit No. 15503, 1990 - A. Ostman, existing 10-inch removed) FS Date: 3/19/2009

Pump house located on landward side.

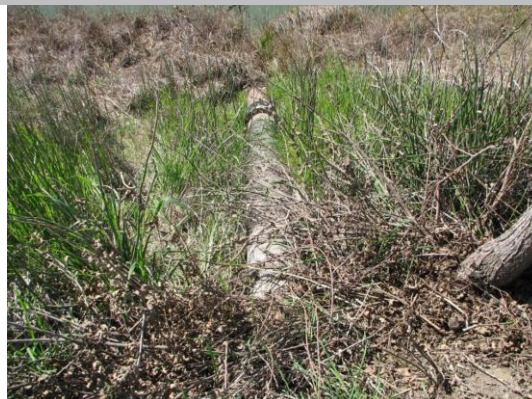
Photo 2 of 2 : UCIP\_FA\_2019\_43455\_36782.jpg

View of waterward side.

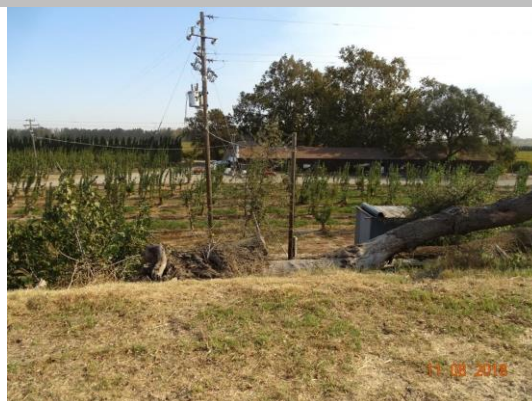
Photo 1 of 1 : FA\_2019\_RD0349\_206\_75\_20190826\_00019.jpg

LM Start	3.96	Rating **	M	Issue No.	75
LM End	3.96	Issue Type +	En	Location *	LS
Category	Earthen Levee			GPS Latitude/Longitude	
				Start	End
Item	Encroachments			38.307532°	38.307532°
				-121.596888°	-121.596888°
DWR ID	DWR_RD0349_03_s_2018_75				
Comment Code					
TR : Tree or limb					
Inspector Comment					
Remove fallen tree on landside slope.

View of fallen tree on the landside slope (November 2018).

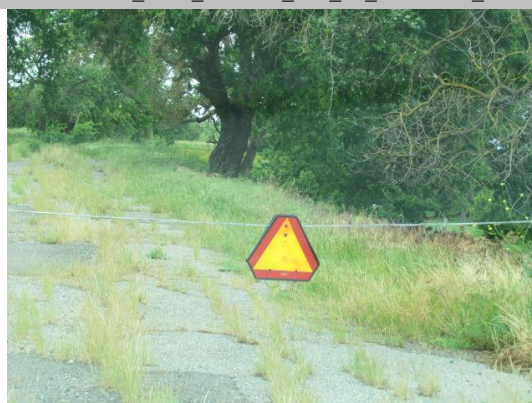
Photo 1 of 1 : FA\_2019\_RD0349\_206\_25\_20190826\_00003.jpg

LM Start	3.99	Rating **	U	Issue No.	25
LM End	3.99	Issue Type +	En	Location *	CR
Category	Earthen Levee			GPS Latitude/Longitude	
				Start	End
Item	Encroachments			38.307997 °	38.307997 °
				-121.597039 °	-121.597039 °
DWR ID	DWR_RD0349_03_s_2012_25				
Comment Code					
FE : Fence					
Inspector Comment					
Unauthorized cable gate crossing levee. Cable gates crossing the levee crown have been prohibited. This encroachment should be removed.

Cable crossings has been banned. They are unauthorized.

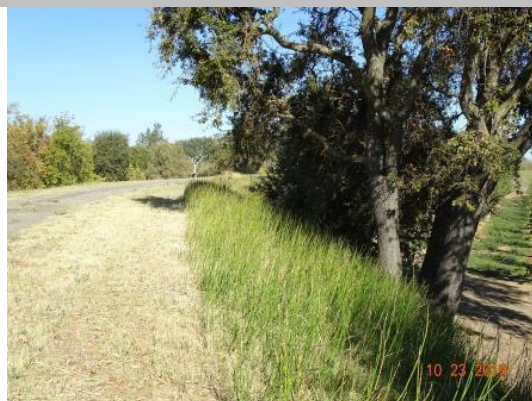
Photo 1 of 1 : FA\_2019\_RD0349\_206\_79\_20191025\_00099.jpg

LM Start	4.06	Rating **	U	Issue No.	79
LM End	4.21	Issue Type +	Ma	Location *	LS
Category	Earthen Levee			GPS Latitude/Longitude	
				Start	End
Item	Vegetation			38.308898 °	38.310578 °
				-121.597703 °	-121.597062 °
DWR ID	DWR_RD0349_03_f_2019_79				
Comment Code					
V1 : Control annual grass and weeds on the levee slopes and easements.					
Inspector Comment

View looking upstream at vegetation on the landside slope (Fall 2019).

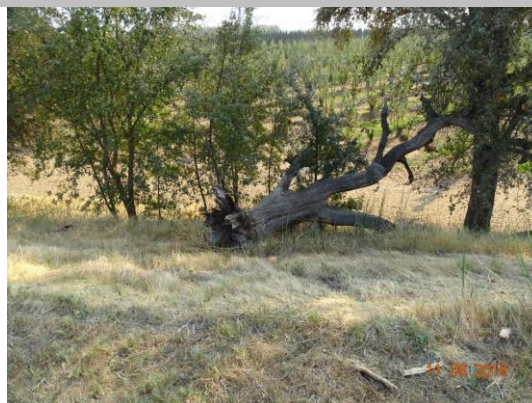
Photo 1 of 1 : FA\_2019\_RD0349\_206\_102\_20190826\_00023.jpg

LM Start	4.19	Rating **	M	Issue No.	102
LM End	4.19	Issue Type +	Ma	Location *	LS
Category	Earthen Levee			GPS Latitude/Longitude	
				Start	End
Item	Encroachments			38.310490 °	38.310490 °
				-121.597265 °	-121.597265 °
DWR ID	DWR_RD0349_03_f_2018_102				
Comment Code					
TR : Tree or limb					
Inspector Comment					
Remove tree from the landside slope.

View of tree on the landside slope (November 2018).

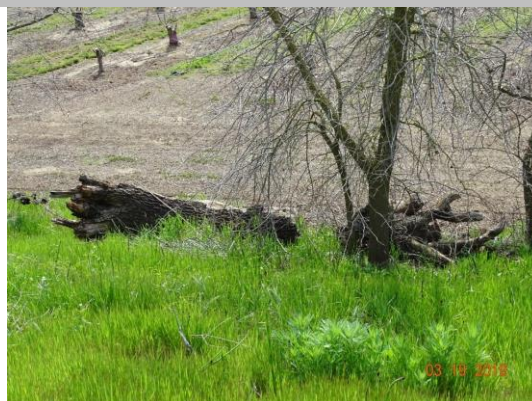
Photo 1 of 1 : FA\_2019\_RD0349\_206\_58\_20190826\_00013.jpg

LM Start	4.22	Rating **	U	Issue No.	58
LM End	4.22	Issue Type +	En	Location *	LS
Category	Earthen Levee			GPS Latitude/Longitude	
				Start	End
Item	Encroachments			38.310675 °	38.310675 °
				-121.596845 °	-121.596845 °
DWR ID	DWR_RD0349_03_s_2019_58				
Comment Code					
TR : Tree or limb					
Inspector Comment					
Remove downed tree trunks from landside slope.

View looking downstream at downed tree trunk on the landside slope (Spring 2019).

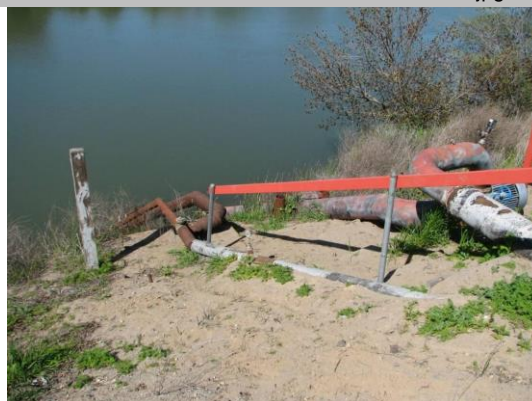
Photo 1 of 1 : UCIP\_FA\_2019\_43458\_36784.jpg

Comment Code						
Inspector Comment						
DS_ID:24183 FS_ID:43458 EP_NO: 8681 Repair Type: Non-Urgent Crossing Status: Found UCIP Comments: Need to contact owner to determine status of crossing. If crossing is no longer in use owner will need to coordinate with DWR inspector and CVFPB to remove according to Title 23 requirements. Dense vegetation limits the inspector's visibility to identify signs of pipe failure (leaks) through the levee slopes. Recommend removing vegetation along pipe alignment to conduct proper inspection of structure and appurtenances. Note date on photos should be 3/18/09 not 7/26/08 camera metadata is incorrect. FIELD_STRUCT_DESC: 1 of 2: 6-inch steel irrigation pipe and 1.5-inch steel electrical conduit through the levee, 4.1 feet and 2.0 feet below the crown, respectively. Steel cutoff wall around pipe and conduit at center of levee. Pump on platform and gate valve on the waterside (WS) slope, not connected. Exposed suction pipe from pump to channel. Rock revetment on WS slope. (12-inch and 6-inch with pump authorized under Permit No. 8681, 1973 - C. Van Loben Sels) [Additional Reference(s): DWR Levee Log, 2005] FS Date: 3/19/2009

View of waterward side. 2 crossing visible 12-inch and 6-inch pipes.

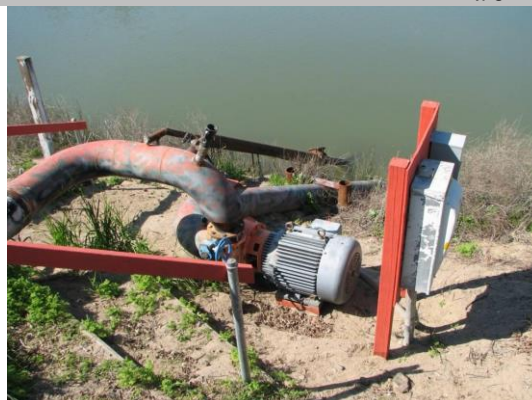
Photo 2 of 3 : UCIP\_FA\_2019\_43457\_36792.jpg

Comment Code					
Inspector Comment					
DS_ID:24184 FS_ID:43457 EP_NO: 8681 Repair Type: Non-Urgent Crossing Status: Found UCIP Comments: Need to contact owner. Is filter sytem located on landward side part of crossing. If so need permit number authorizing work. Also if crossing is no longer used by owner, the owner will need to coordinate with DWR Inspector and CVFPB to remove crossing according to Title 23 requirements. Dense vegetation limits the inspector's visibility to identify signs of pipe failure (leaks) through the levee slopes. Recommend removing vegetation along pipe alignment to conduct proper inspection of structure and appurtenances. Note date on photos should be 3/18/09 not 7/26/08 camera metadata is incorrect. FIELD_STRUCT_DESC: 2 of 2: 12-inch steel irrigation pipe through the levee, 4.3 feet below the crown. Steel cutoff wall around pipe at center of levee. Pump on platform and gate valve on the waterside (WS) slope. Exposed suction pipe from pump to channel. Rock revetment on WS slope. (12-inch and 6-inch with pump authorized under Permit No. 8681, 1973 - C. Van Loben Sels) [Additional Reference(s): DWR Levee Log, 2005] FS Date: 3/19/2009

Pump associated with 12-inch pipe.

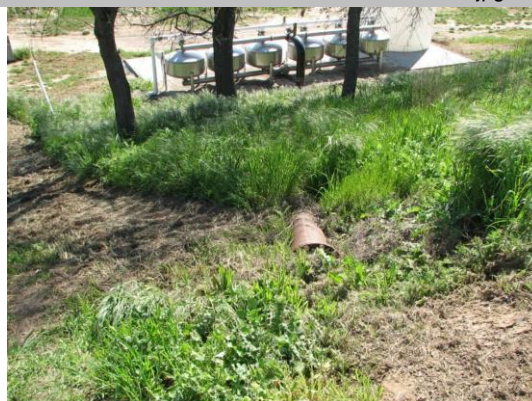
Photo 3 of 3 : UCIP\_FA\_2019\_43457\_36790.jpg

Comment Code						
Inspector Comment						
DS_ID:24184 FS_ID:43457 EP_NO: 8681 Repair Type: Non-Urgent Crossing Status: Found UCIP Comments: Need to contact owner. Is filter sytem located on landward side part of crossing. If so need permit number authorizing work. Also if crossing is no longer used by owner, the owner will need to coordinate with DWR Inspector and CVFPB to remove crossing according to Title 23 requirements. Dense vegetation limits the inspector's visibility to identify signs of pipe failure (leaks) through the levee slopes. Recommend removing vegetation along pipe alignment to conduct proper inspection of structure and appurtenances. Note date on photos should be 3/18/09 not 7/26/08 camera metadata is incorrect. FIELD_STRUCT_DESC: 2 of 2: 12-inch steel irrigation pipe through the levee, 4.3 feet below the crown. Steel cutoff wall around pipe at center of levee. Pump on platform and gate valve on the waterside (WS) slope. Exposed suction pipe from pump to channel. Rock revetment on WS slope. (12-inch and 6-inch with pump authorized under Permit No. 8681, 1973 - C. Van Loben Sels) [Additional Reference(s): DWR Levee Log, 2005] FS Date: 3/19/2009

View of pipe and filter system on landward side.

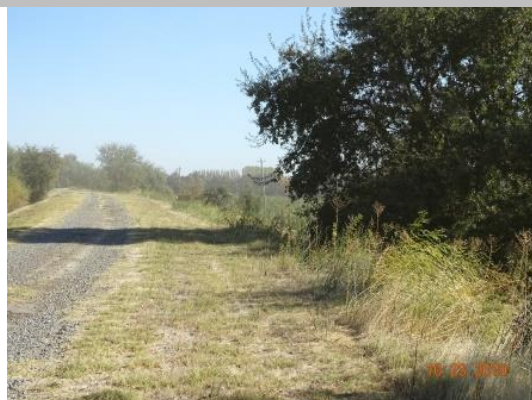
Photo 1 of 1 : FA\_2019\_RD0349\_206\_80\_20191025\_00100.jpg

LM Start	4.30	Rating **	U	Issue No.	80
LM End	5.10	Issue Type +	Ma	Location *	LS
Category	Earthen Levee			GPS Latitude/Longitude	
				Start	End
Item	Vegetation			38.311227 °	38.321193 °
				-121.595547 °	-121.589720 °
DWR ID	DWR_RD0349_03_f_2019_80				
Comment Code					
V1 : Control annual grass and weeds on the levee slopes and easements.					
Inspector Comment

View looking upstream at vegetation the landside slope (Fall 2019).

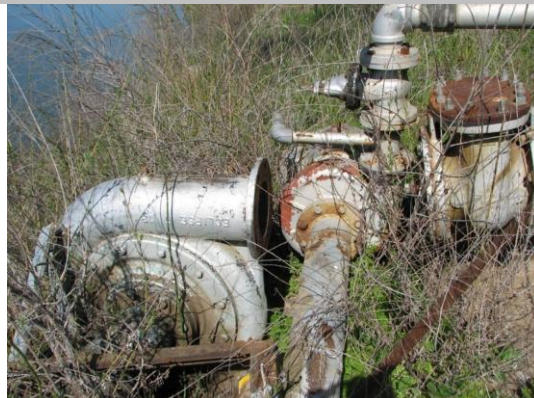
Photo 2 of 3 : UCIP\_FA\_2019\_43459\_36795.jpg

Comment Code						
Inspector Comment						
DS_ID:24185 FS_ID:43459 EP_NO: N/A Repair Type: Non-Urgent Crossing Status: Found UCIP Comments: No connection present--need to contact owner to determine if owner plans to use. If crossing is no longer in use owner will need to coordinate with DWR inspector and CVFPB to remove according to Title 23 requirements. Recommend removing vegetation along pipe alignment. Note date on photos should be 3/18/09 not 7/26/08 camera metadata is incorrect. FIELD_STRUCT_DESC: *ABANDONED* 10-inch steel irrigation pipe and 2-inch electrical conduit through the levee, both 2.8 feet below the levee crown. Abandoned pumps and gate valve on the waterside (WS) slope. Service pole on the landside (LS) slope. Concrete headwall on LS. [Additional Reference(s): DWR Levee Log, 2005. USACE Sacramento O&M Manual Unit No. 110, May 1959, revised 29 Dec 2016, (HLM 4.8)] FS Date: 3/19/2009

Pump located on waterward side is not connected.

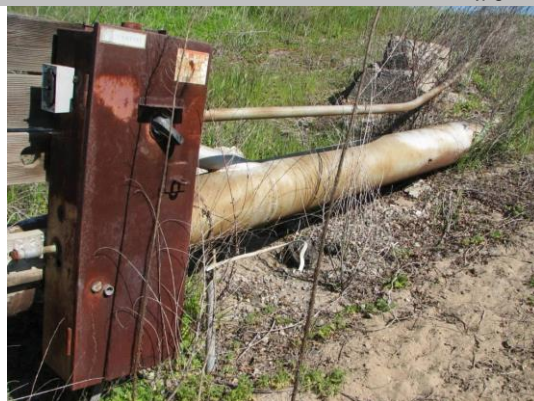
Photo 3 of 3 : UCIP\_FA\_2019\_43459\_36797.jpg

Pipe on waterward side.

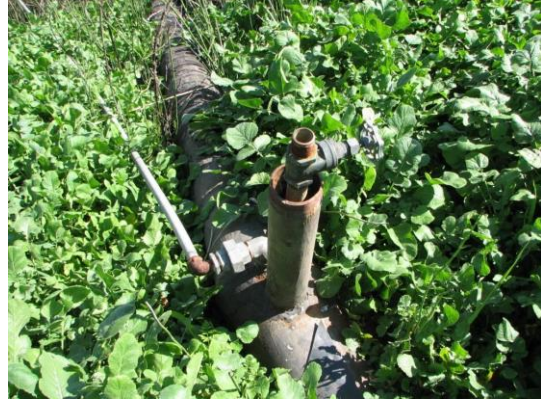
Photo 1 of 3 : UCIP\_FA\_2019\_43431\_36800.jpg

Comment Code					
Inspector Comment					
DS_ID:24186 FS_ID:43431 EP_NO: 15359 Repair Type: Non-Urgent Crossing Status: Found UCIP Comments: Dense vegetation limits the inspector's visibility to identify signs of pipe failure (leaks) through the levee slopes. Recommend removing vegetation along pipe alignment to conduct proper inspection of structure and appurtenances. Note date on photos should be 3/18/09 not 7/26/08 camera metadata is incorrect. FIELD_STRUCT_DESC: 10-inch steel irrigation pipe sleeved through a 12-inch conductor pipe through the levee, 6.0 feet below the levee crown. Siphon breaker in protective house at levee shoulder. Pump in pump house and power pole at landside (LS) toe. Pipe connected to 8-inch exposed pipe at LS shoulder, extending to pump house. Filter screen in channel at waterside (WS) toe. (existing 4-inch pipe removed and new 10-inch sleeved through 12-inch installed under Permit No. 15359, 1990 - E. Delta Orchards) [Additional Reference(s): DWR Levee Log, 2005] FS Date: 3/19/2009

Air vent located on pipe on landward.
